**Site Address:**

123 Street Name
Raleigh, NC 27613

Inspection Date: 00.00.26 – 1p

Home Inspection Report

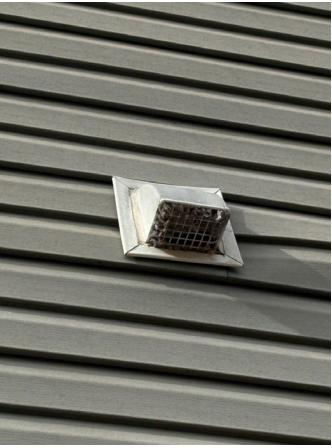
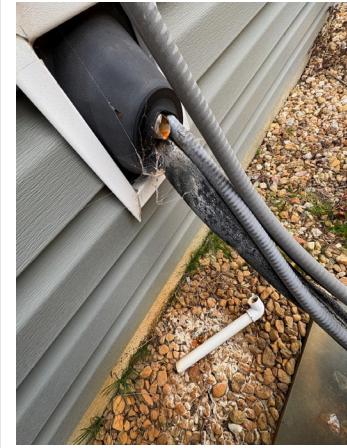
Clogged Dryer Vent (Right, Top)	Non Sealed Opening Around Condensation Line (Right, Bottom)	Damaged Bathroom Vent Casing (Left, Top)	Damaged and Detached Condensation Line at HVAC (Left, Bottom)

Multiple deficiencies were observed at exterior wall penetrations and vent terminations, including a clogged dryer vent, an unsealed opening around an HVAC condensate line penetration, a damaged bathroom exhaust vent casing, and a damaged and detached HVAC condensate line. These conditions indicate compromised venting and wall sealing at the time of inspection. Improper vent terminations and unsealed penetrations can contribute to reduced appliance performance, moisture intrusion, pest entry, or improper condensate drainage. It is recommended that the dryer vent be cleaned, damaged components be repaired or replaced, and all wall penetrations be properly sealed to restore intended function and weather resistance.

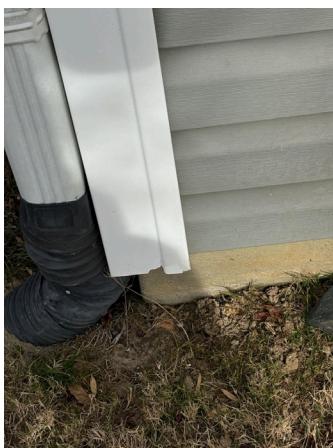
Damage was observed at the bottom left trim near the garage door, consistent with impact from lawn maintenance equipment. This condition indicates localized deterioration of the trim material. Damaged trim can allow moisture intrusion and may continue to deteriorate if left unaddressed. Repair or replacement of the affected trim is recommended to help maintain proper protection of the underlying materials.

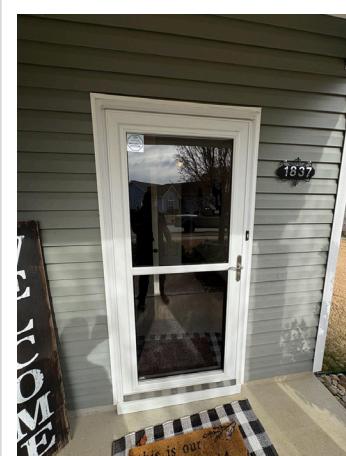
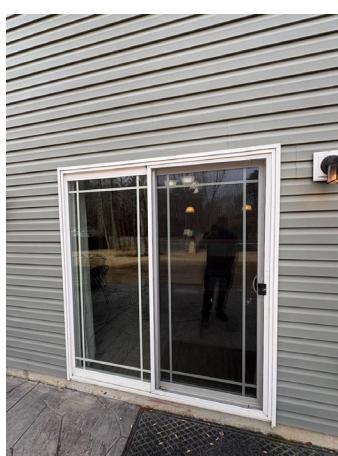
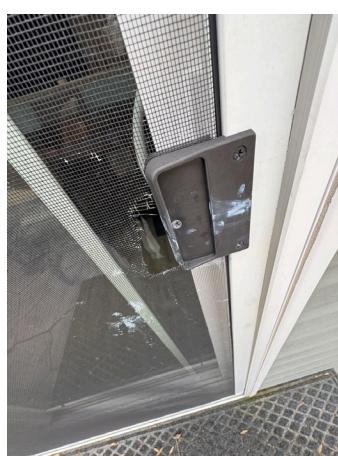
The sliding screen at the rear door was observed to be damaged near the handle area at the time of inspection. This condition indicates the screen is not fully intact. A damaged screen can reduce its intended function for ventilation and insect control and may continue to worsen with use. Repair or replacement of the damaged screen is recommended.

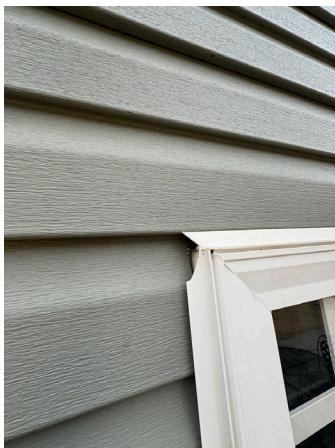
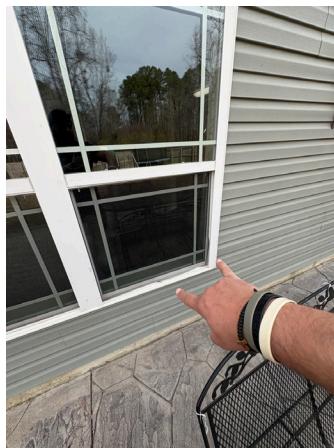
The back right window was observed to have a broken trim piece, creating a noticeable gap at the window assembly, indicating the opening is not properly sealed. Additionally, the lower right portion of the window screen was observed to be damaged. Gaps at window trim and damaged screens can allow water intrusion and pest entry, which may lead to moisture-related damage over time. Repair or replacement of the damaged trim and screen, along with proper sealing of the opening, is recommended to help maintain weather resistance and functionality.

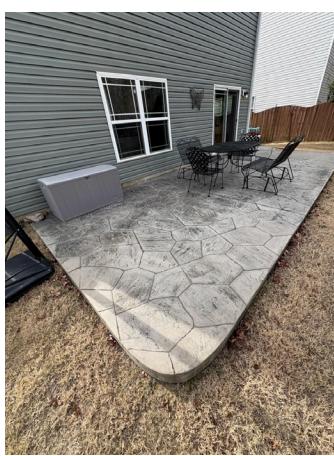
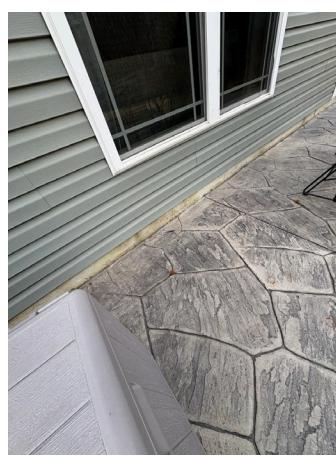
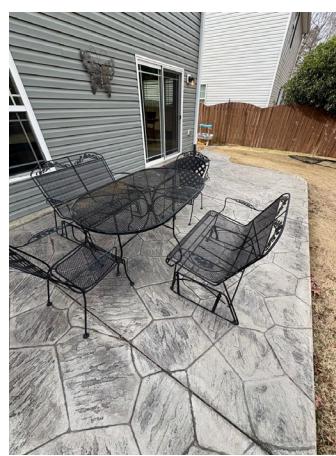
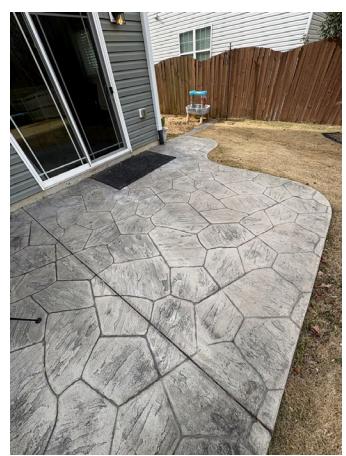
The rear stepped patio was observed to have a noticeable step up at the time of inspection. While no defect was noted, this change in elevation may pose a minor trip hazard if not anticipated. Occupants and visitors should use caution when transitioning onto the patio, especially in low-light conditions or when the surface is wet.

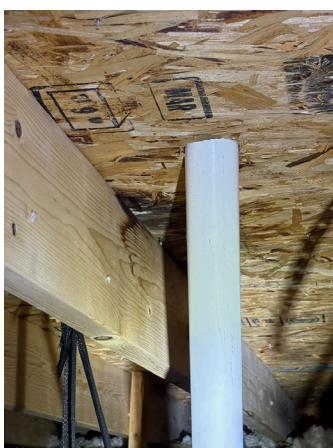
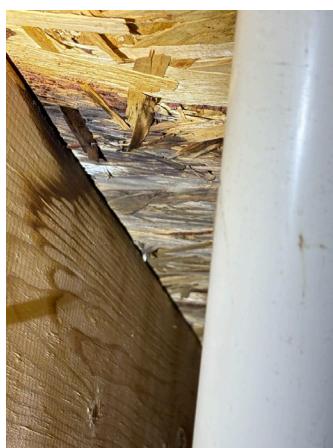
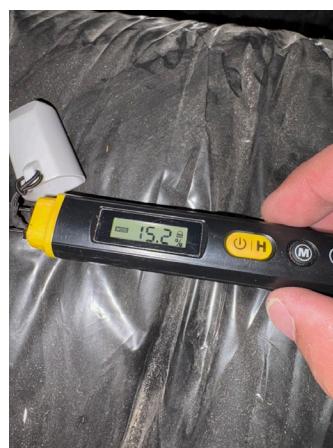
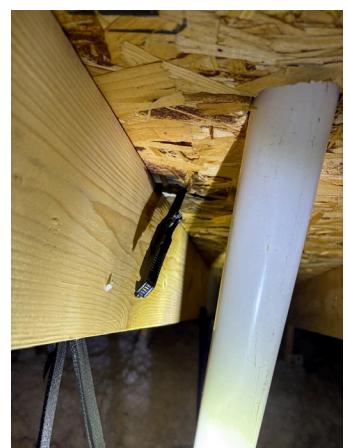
A localized area of roof sheathing, approximately fist-sized, was observed to exhibit moisture-related damage to the OSB sheathing, with the adjacent rafter showing visible staining consistent with past or ongoing water intrusion. Moisture readings in this area measured approximately 15–16%; however, the darkened portion of the sheathing was observed to be significantly soft and deteriorated, allowing a hand tool to easily penetrate through the material to the underside of the shingles. This condition indicates advanced deterioration of the sheathing at this location and suggests that a roof leak may have occurred or may still be present. Further evaluation and repair by a qualified roofing contractor is recommended, including assessment of the roofing materials above this area and replacement of any damaged sheathing as needed to help prevent continued moisture intrusion and structural degradation.

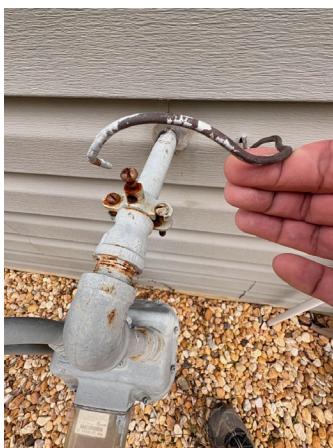
The gas piping was observed to not be bonded at the time of inspection. This condition indicates the gas piping is not electrically connected to the grounding system as intended. Improper or missing bonding may increase the risk of electrical shock in the event of a fault. Correction by a qualified electrician, or another individual experienced and confident in performing the repair, is recommended to ensure the system is properly bonded.

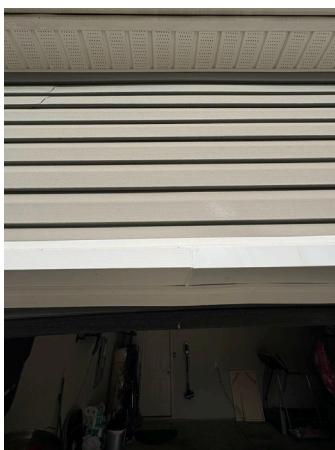
The vinyl siding appeared to be in good condition at the time of inspection. A prior repair was noted at the garage trim area; no deficiencies were observed. It is recommended to monitor this repair over time for any changes or signs of deterioration.

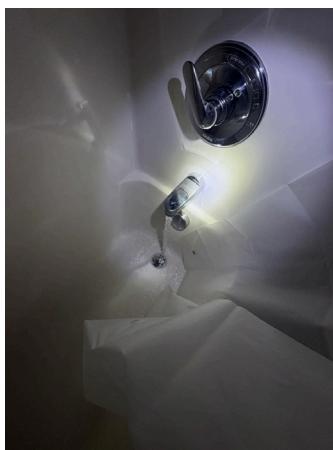
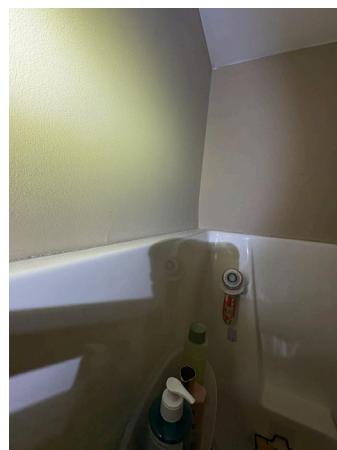
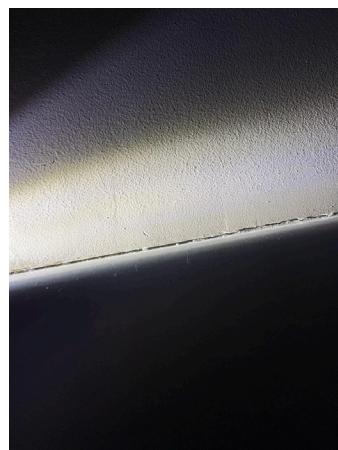
The master bathroom shower stall and faucet area were observed to have missing caulk, with small gaps present at the time of inspection. These gaps indicate the area is not fully sealed. Unsealed joints can allow water intrusion, which may lead to moisture-related damage over time. Sealing the affected areas with appropriate bathroom-grade caulk is recommended to help prevent water intrusion.

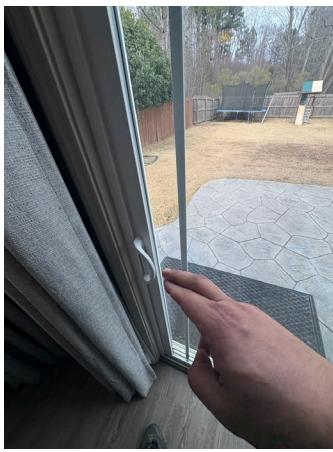
The rear sliding glass door lock was observed to be not operational at the time of inspection. This condition indicates the door does not provide its intended level of security. Repair or replacement of the lock mechanism is recommended to restore proper operation and security.

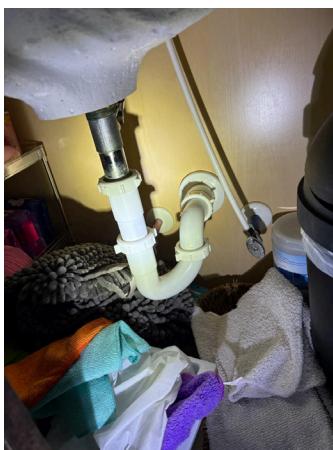
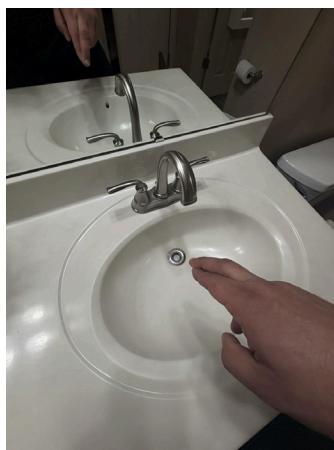
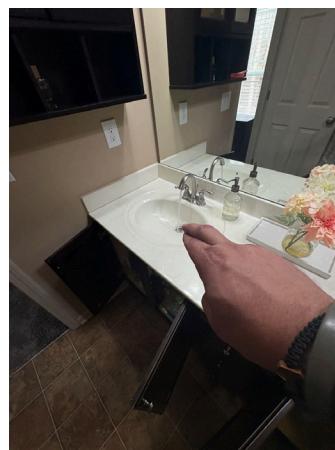
The master bathroom sink faucets were observed to be operational at the time of inspection. Debris and hair-catching stoppers were installed in the drains, which prevented the sink stoppers from operating as originally intended. As a result, the sink stoppers did not function at the time of inspection. This condition is noted as a functional deficiency; **however, the installed stoppers may be a homeowner preference**. Adjustment or replacement is recommended.

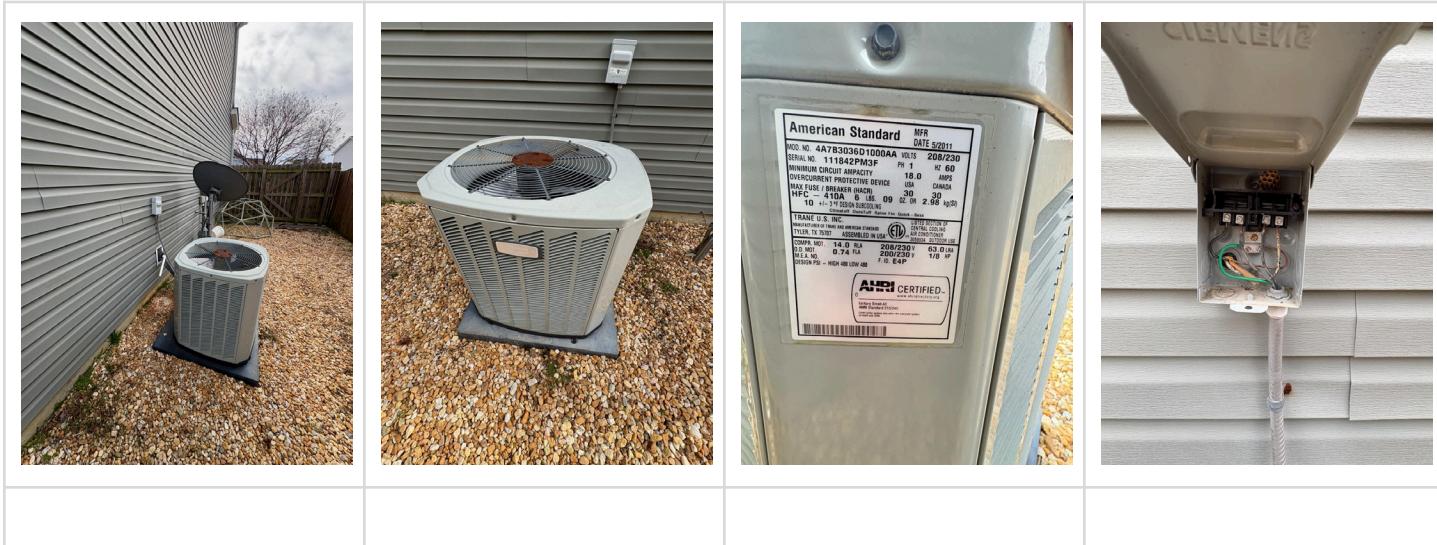
The HVAC system was observed to be original to the home. At the time of inspection, the system was operational; however, its overall condition was considered marginal due to age, indicating it may be approaching the end of its typical service life. While no immediate deficiencies were noted, increased maintenance needs or replacement should be anticipated. Continued monitoring and budgeting for future repair or replacement is recommended.

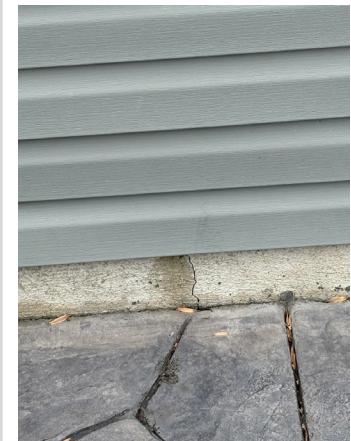
Hairline Crack – Right, Back

Several foundation cracks were observed, including hairline cracks at multiple locations and a wider crack at the left middle area measuring approximately 1/4 inch. Cracking at this location was also observed to correspond with cracking at the garage foundation wall. Hairline cracking can be associated with normal curing and typical settlement; however, the presence, width, and alignment of the larger crack warrant further consideration. While no signs of structural failure were observed at the time of inspection, further evaluation by a qualified structural engineer or foundation professional is recommended to assess conditions and provide written documentation regarding the foundation at the time of inspection, which may help provide clarity and reassurance regarding the foundation's condition.

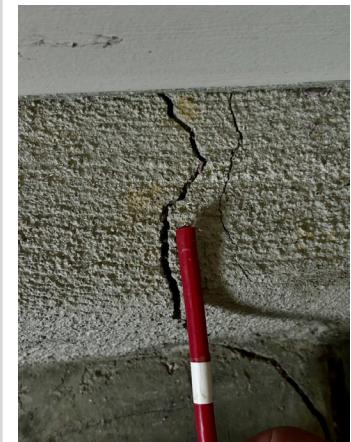
Crack – Left, Middle
(Corresponds to Garage Foundation Crack)
