**Site Address:**  
123 Street Name  
Raleigh, NC 27613

**Kevin Polonofsky - #6078**  
[kevinp@relihi.com](mailto:kevinp@relihi.com)  
919.805.3955

**Inspection Date:** 00.00.26 – 12p

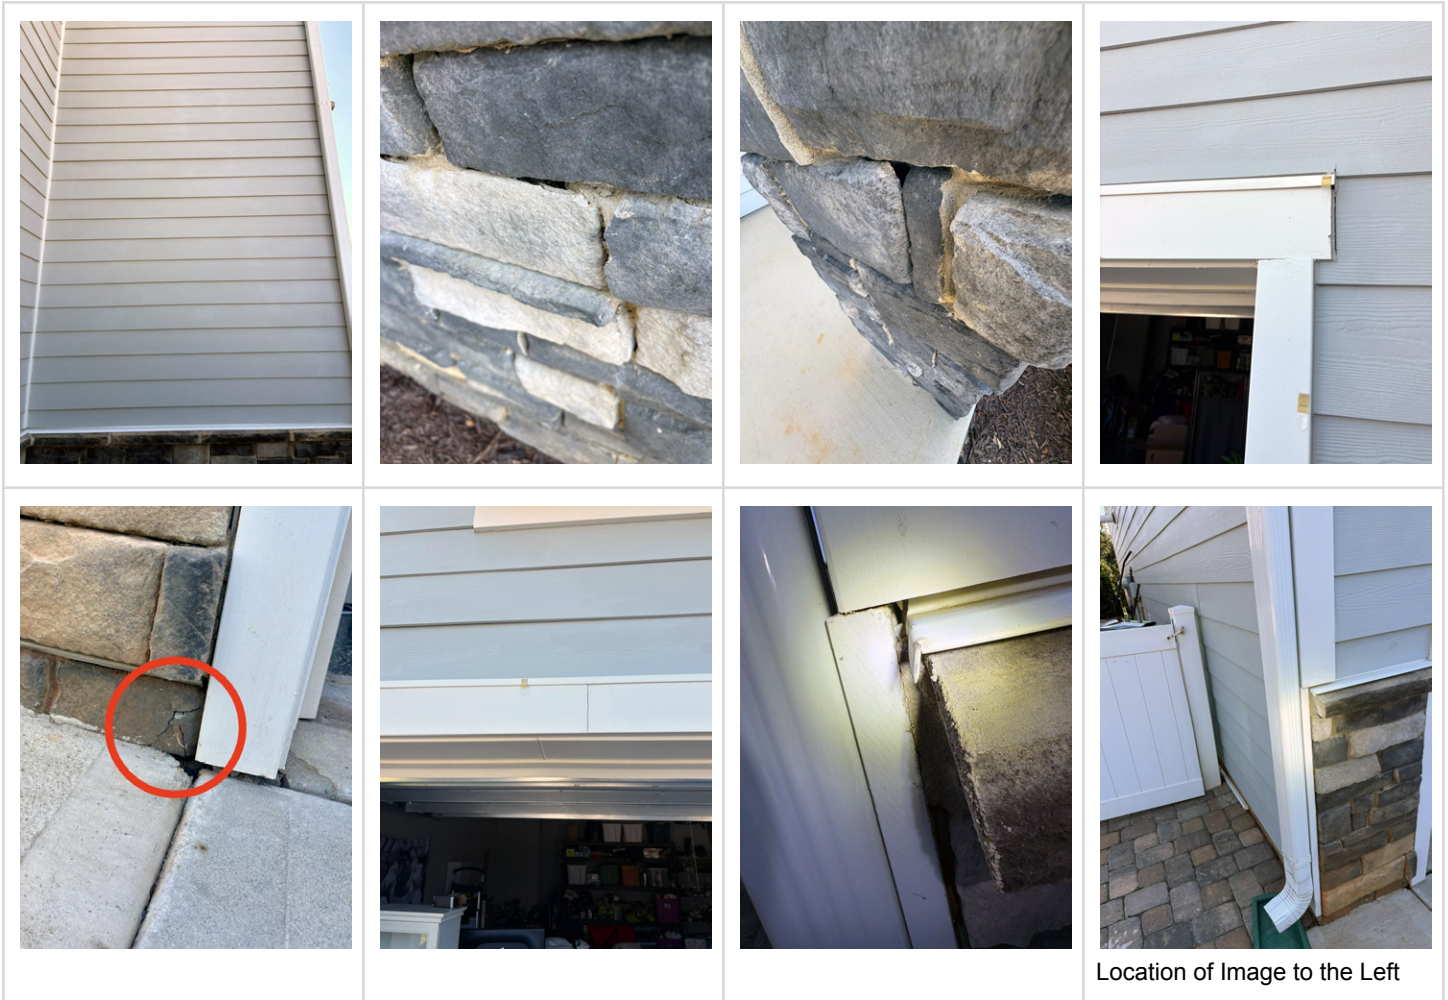
**Maintenance** ▾ Open gaps and localized areas of missing or deteriorated mortar were observed in the stone veneer. Open mortar joints can allow moisture to enter behind the veneer and may contribute to continued deterioration of the surrounding materials. Recommend repairing the affected mortar joints with an appropriate compatible material and maintaining proper drainage provisions behind the veneer.

Open gaps were observed along the right and left sides of the garage door where the trim meets the adjacent exterior materials. Missing or deteriorated sealant at these transitions can allow moisture and pests to enter behind the trim or adjoining wall materials. Recommend properly sealing the affected joints with an appropriate exterior-grade sealant.

A stone veneer unit at the lower-left side of the garage was observed to be cracked. A cracked veneer unit can continue to deteriorate and may allow moisture to enter adjoining joints or concealed materials. Recommend repair or replacement of the damaged stone by a qualified masonry contractor.

The center trim at the garage door had an open joint where trim boards connect, and sealant was also missing at the upper-left front corner where the stone veneer meets the adjacent trim board. Open joints at these transitions can allow moisture entry and contribute to deterioration of the surrounding materials. Recommend properly sealing the affected trim-to-trim and trim-to-stone transitions with an appropriate exterior-grade sealant.

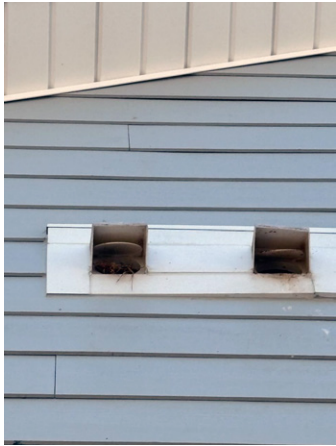
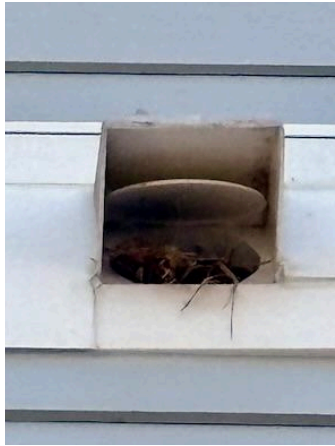
Nesting activity was observed at the bathroom exhaust vent termination on the left side of the home. Nesting material can restrict airflow and may interfere with proper exhaust of moisture from the bathroom. Recommend removal of the nesting material and evaluation of the vent termination to confirm it is clear, functional, and fitted with an appropriate exterior hood or damper that discourages pest entry without restricting airflow.

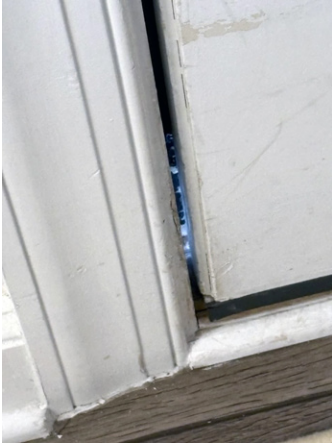
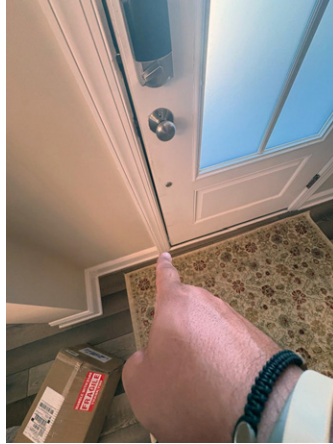
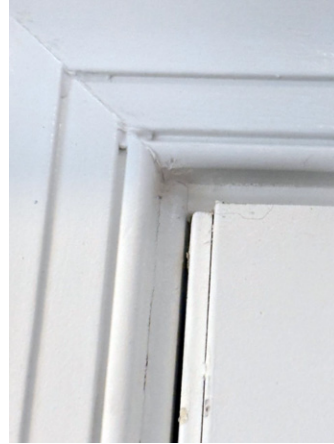
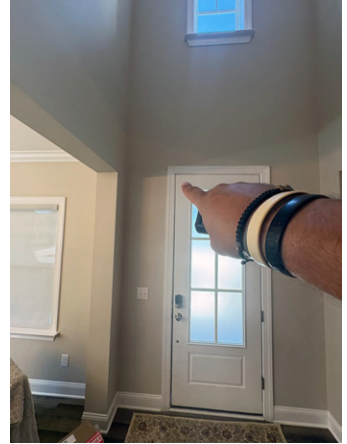
Visible air gaps were observed at the upper-left and lower-left portions of the front door even when the door was fully closed and locked. Gaps at the door perimeter can allow air, moisture, and insects to enter and may reduce the effectiveness of the weather seal. Recommend adjustment of the door and/or replacement or repair of the weatherstripping as needed to improve the seal while maintaining proper door operation.

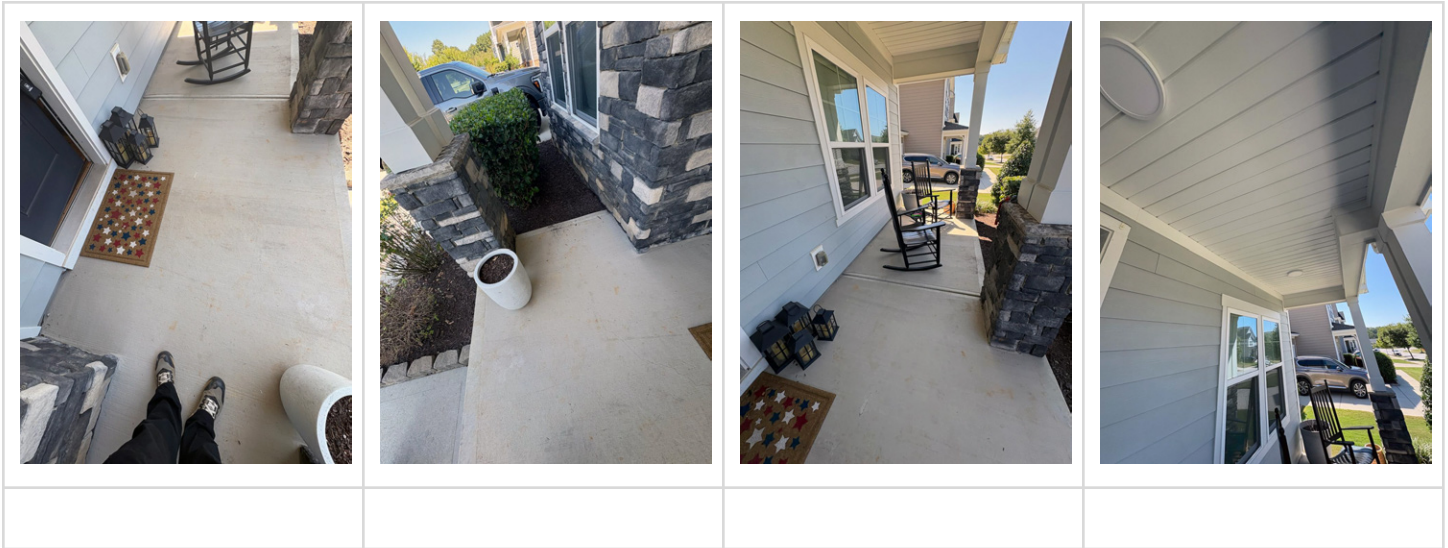
*Minor hairline cracks were observed in the concrete front porch slab. No significant displacement or other readily visible signs of movement were noted at the time of the inspection. Hairline cracking can occur from normal shrinkage or minor movement of concrete. Recommend routine sealing and monitoring for changes in width, displacement, or moisture intrusion.*

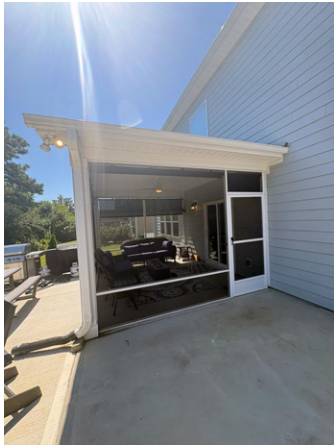
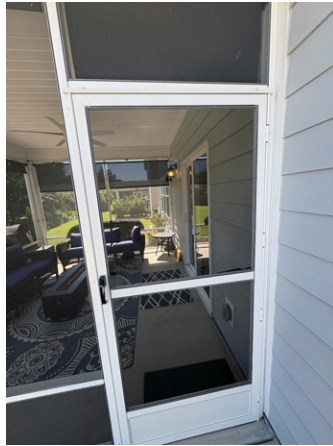
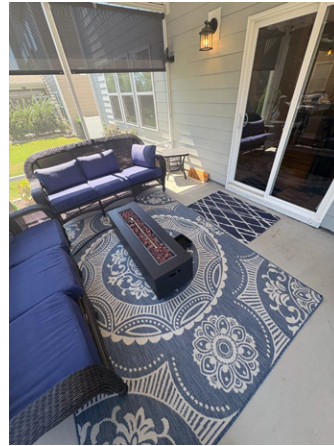
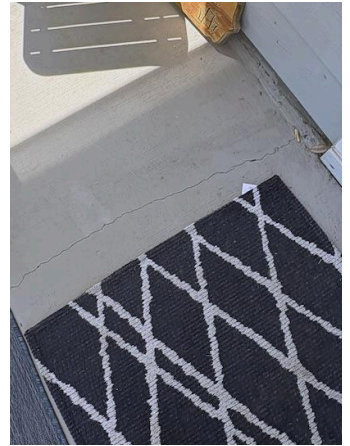
*Minor hairline cracks were observed in the concrete rear porch slab. No significant displacement or other readily visible signs of movement were noted at the time of the inspection. Hairline cracking can occur from normal shrinkage or minor movement of concrete. Recommend routine sealing and monitoring for changes in width, displacement, or moisture intrusion.*

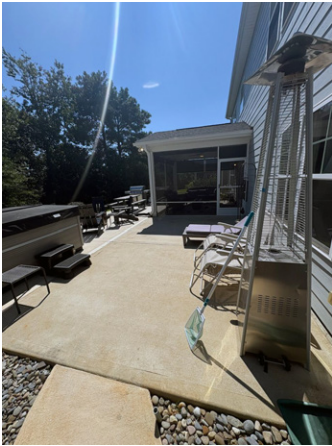
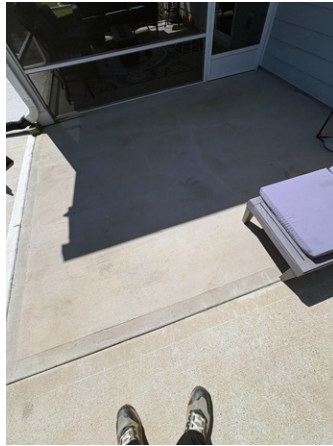
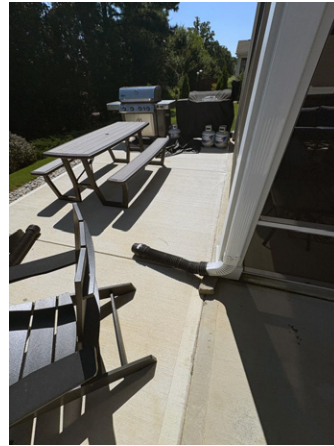
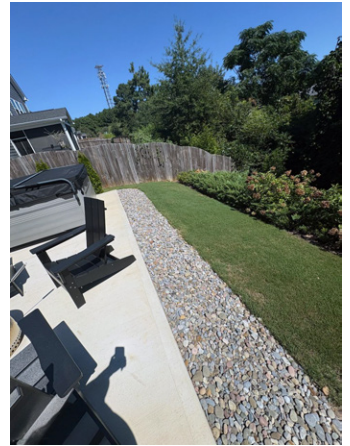
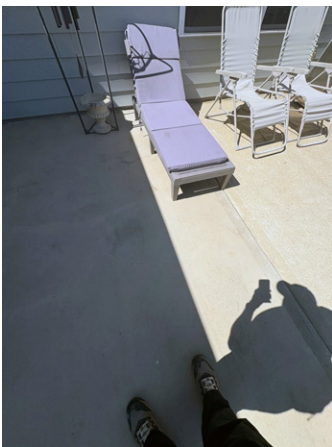
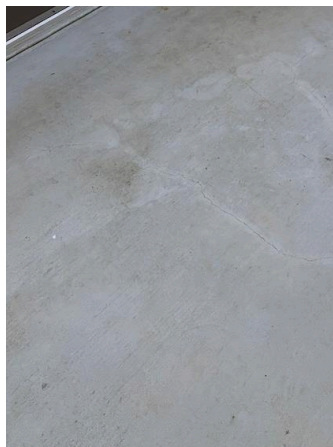
*Minor hairline cracks were observed in the concrete patio slab. No significant displacement or other readily visible signs of movement were noted at the time of the inspection. Hairline cracking can occur from normal shrinkage or minor movement of concrete. Recommend routine sealing and monitoring for changes in width, displacement, or moisture intrusion.*

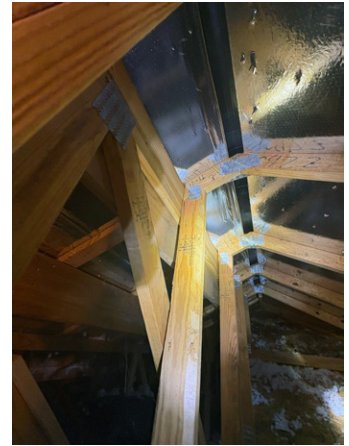
In the attic, to the right of the stairs just beyond the landing area, a purlin spanning across the upper roof-framing system was observed to be cracked near the front portion of the member. The first truss chord connected at this location was also visibly split near the top and exhibited additional cracking near the lower portion where supporting members had been fastened. These conditions affect multiple connected roof-framing components, and the extent and structural significance of the damage could not be determined during this visual inspection. Recommend evaluation by a licensed structural engineer to determine whether repair or reinforcement is needed and to provide repair recommendations as appropriate.

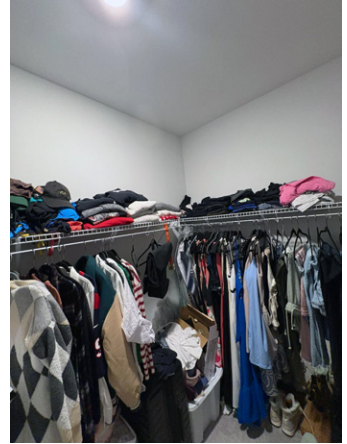
Minor cosmetic conditions were observed throughout the home, including scuff marks on walls and ceilings, rub marks near door hinges, hooks and light fixtures attached to finished surfaces, minor drywall imperfections, and isolated nail pops. These conditions appeared cosmetic in nature and were not observed to affect the intended function of the associated components at the time of the inspection. No corrective action is required as part of the home inspection; repair or touch-up may be performed as desired.

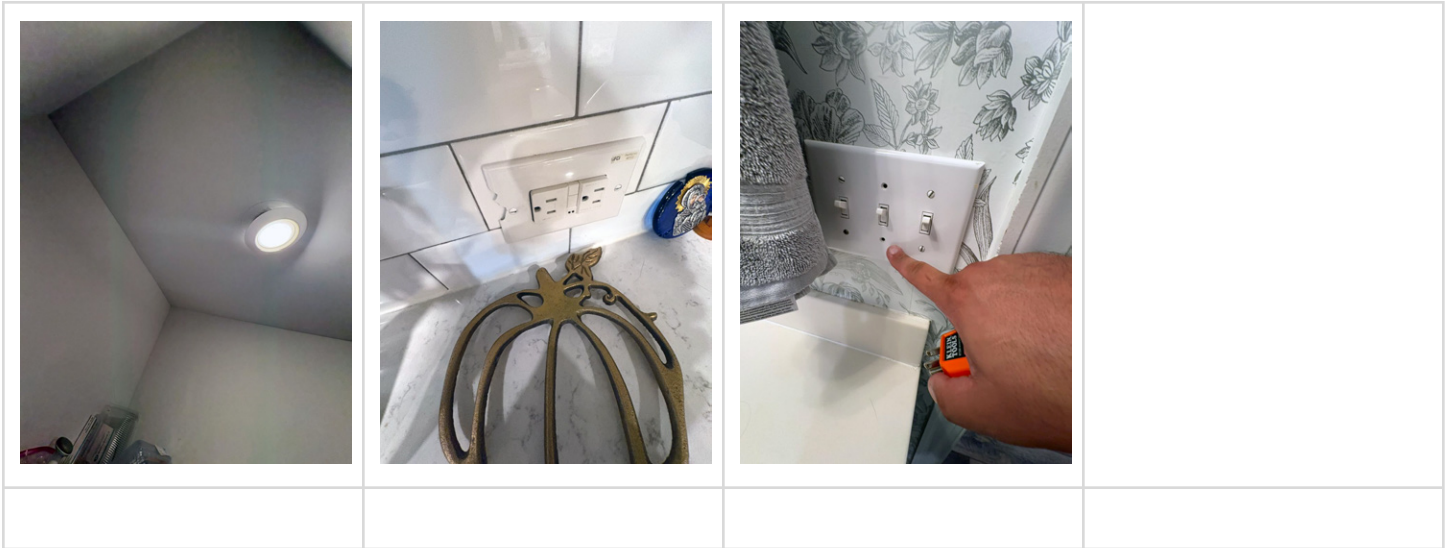
The recessed light fixture in the pantry appeared to be loose and not securely seated within the ceiling opening. A loose fixture can shift from its intended position and may place stress on the trim, housing, or associated wiring. Recommend properly securing the fixture and having it evaluated by a qualified licensed electrical contractor if the housing or mounting components are damaged.

The receptacle cover plate located to the left of the refrigerator was observed to be damaged. A damaged cover plate can leave portions of the electrical device or box more exposed to accidental contact or physical damage. Recommend replacement of the damaged cover plate and repair of the receptacle assembly as needed by a qualified licensed electrical contractor.

The light-switch cover plate in the downstairs bathroom was missing securing screws at the time of the inspection. Missing fasteners can allow the cover plate to become loose or shift from its intended position. Recommend installing the appropriate cover-plate screws and verifying that the switch and cover remain securely mounted.

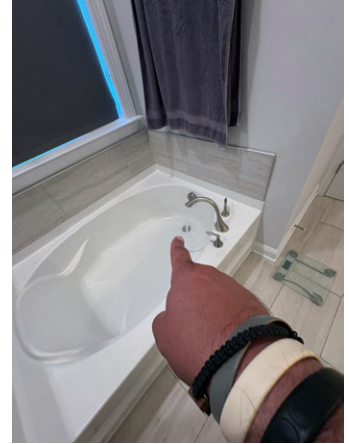
A noticeable reduction in water flow was observed when three or more plumbing fixtures were operated simultaneously. The plumbing system remained functional during testing; however, if stronger simultaneous flow is desired, the client may wish to have a qualified licensed plumbing contractor evaluate the system for possible improvements to water pressure or distribution performance.

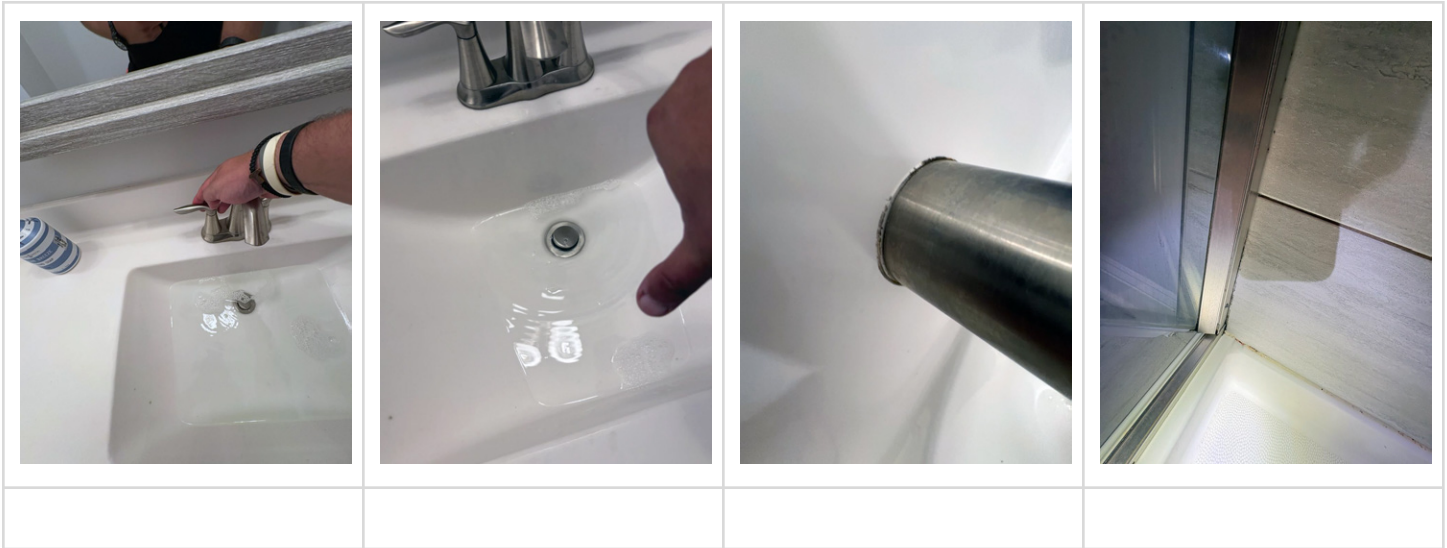
At the upstairs bathroom with the double sink, the hot-water handle at the right-side sink was difficult to operate, and the sink drained slowly when tested. Stiff faucet operation and slow drainage can affect normal use and may be related to fixture wear, buildup, or a partial drainage restriction. Recommend adjustment or repair of the faucet and cleaning or servicing of the drain as needed.

The bathtub faucet/trim in the upstairs bathroom lacked adequate sealant where it meets the finished wall surface. An open or deteriorated joint at a wet-area plumbing penetration can allow moisture to enter adjoining finishes or concealed materials over time. Recommend properly sealing the faucet/trim penetration with an appropriate moisture-resistant sealant.

The primary shower exhibited visible buildup, wear, and areas of sealant that appeared aged or in need of maintenance. These conditions appeared primarily related to routine use and maintenance; however, deteriorated sealant in a wet area can allow moisture to reach adjoining materials over time. Recommend thorough cleaning and renewal of deteriorated sealant as needed to maintain the shower enclosure and surrounding finishes.

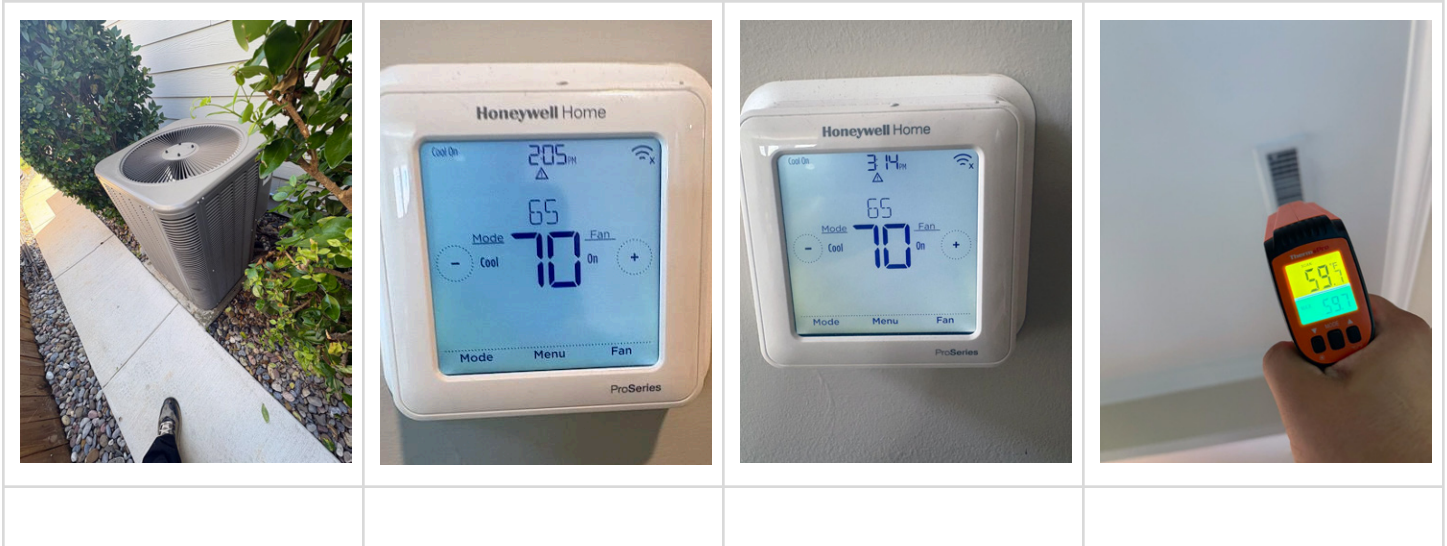
The air-conditioning system was operated using the installed normal operating controls at the time of the inspection. The system responded to the controls and cool air was observed discharging from the supply registers; however, after the thermostat was lowered to approximately 65°F, the interior temperature did not appreciably decrease during the inspection period. Supply air was measured at approximately 10°F cooler than the thermostat setting at the locations tested. While the system was operating and producing cooled air, overall cooling performance could not be confirmed as satisfactory based on the observed temperature response. Recommend evaluation and servicing by a qualified licensed HVAC contractor to determine whether the system is cooling and distributing conditioned air as intended.

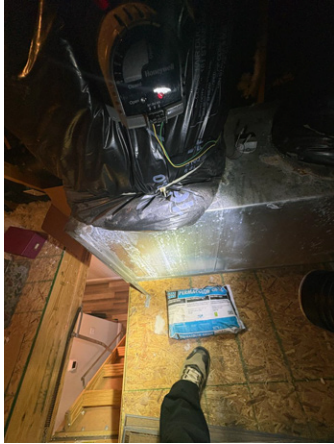
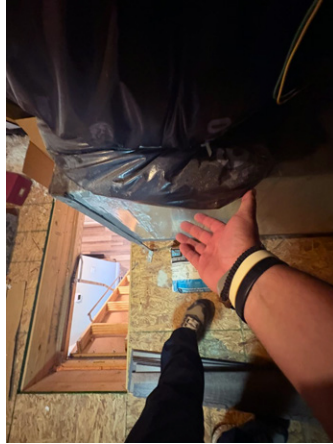
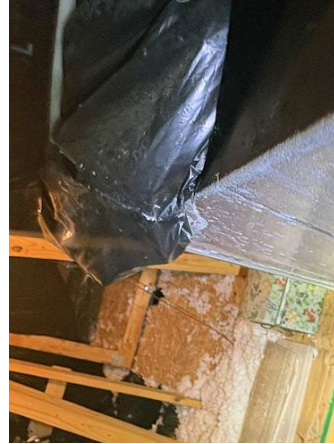
The far-left duct connection at the HVAC unit was observed to be improperly fitted and was actively leaking conditioned air into the attic at the time of the inspection. Air leakage at a duct connection can reduce system efficiency and may affect proper distribution of conditioned air to the home. Recommend evaluation and repair by a qualified licensed HVAC contractor, including properly securing and sealing the affected duct connection.

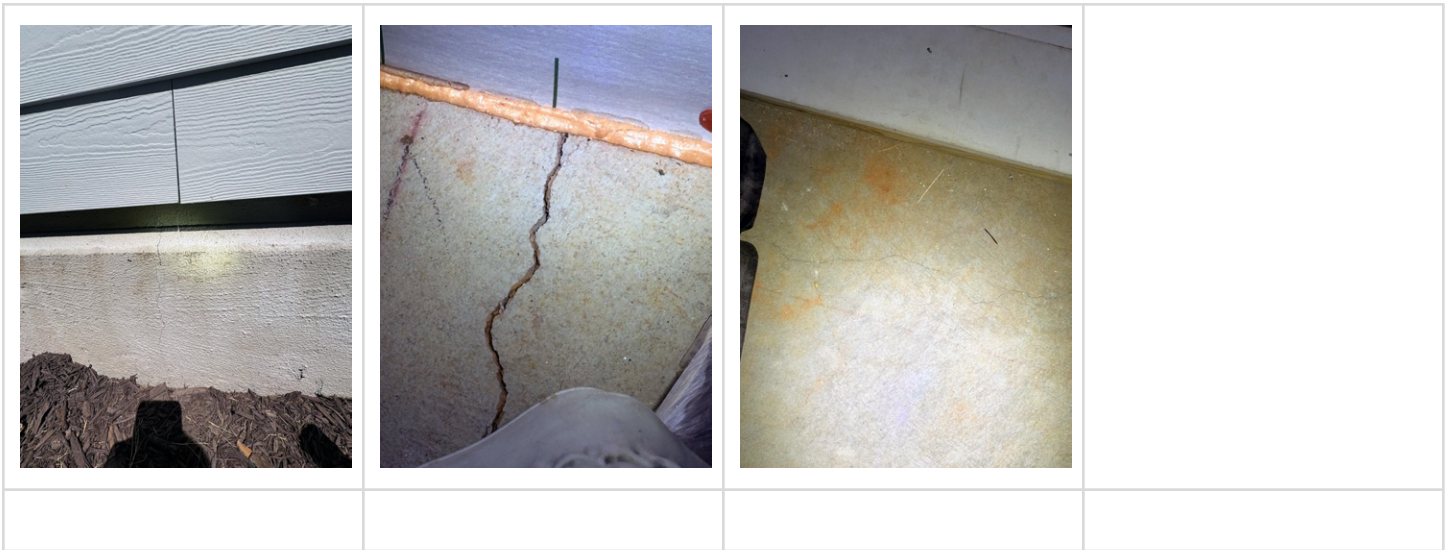
*An insulation layer limited visibility of portions of the slab; however, a crack measuring approximately 1/8 inch or less was observed near the middle-right side of the home and was also visible in the slab beneath the stairs. The crack diminished as it extended away from the observed area, and no other readily visible signs of significant movement or related distress were noted throughout the home at the time of the inspection. Recommend sealing the visible crack as appropriate and monitoring for changes in width, displacement, or associated movement over time. If movement progresses or additional signs of structural distress develop, further evaluation by a licensed structural engineer is recommended.*
