**Site Address:**

123 Street Name
Raleigh, NC 27613

Inspection Date: 00.00.26 – 1p

Home Inspection Report

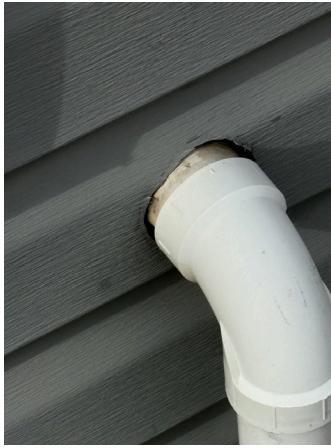
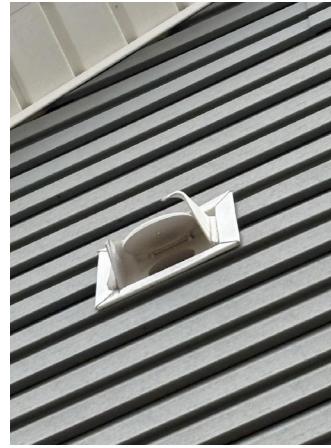
1.5. ⚠ **Exterior: Wall Penetration(s) and Vents**

Clogged Dryer Vent (Right, Top)	Non Sealed Opening Around Condensation Line (Right, Bottom)	Damaged Bathroom Vent Casing (Left, Top)	Damaged and Detached Condensation Line at HVAC (Left, Bottom)

Multiple deficiencies were observed at exterior wall penetrations and vent terminations, including a clogged dryer vent, an unsealed opening around an HVAC condensate line penetration, a damaged bathroom exhaust vent casing, and a damaged and detached HVAC condensate line. These conditions indicate compromised venting and wall sealing at the time of inspection. Improper vent terminations and unsealed penetrations can contribute to reduced appliance performance, moisture intrusion, pest entry, or improper condensate drainage. It is recommended that the dryer vent be cleaned, damaged components be repaired or replaced, and all wall penetrations be properly sealed to restore intended function and weather resistance.

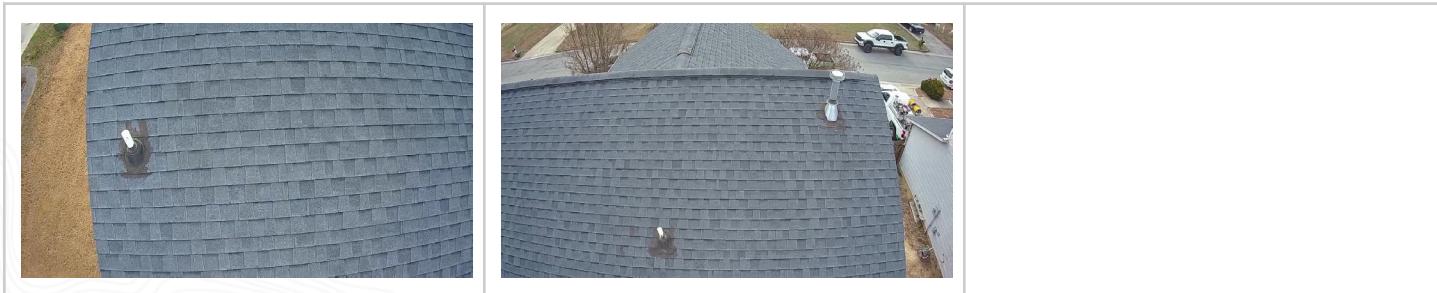
2.2. Roofing: Penetration(s)/Vent(s)

The plumbing vent penetrations and the gas furnace vent were observed to have mastic or roof tar liberally applied around the flashing, which is not typical. No deficiencies were observed at the time of inspection. This condition may indicate a prior repair or an attempt to address a past leak. It is recommended to monitor these penetration points from the attic during routine inspections for any signs of moisture intrusion or deterioration.

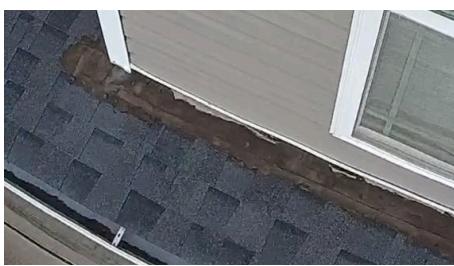
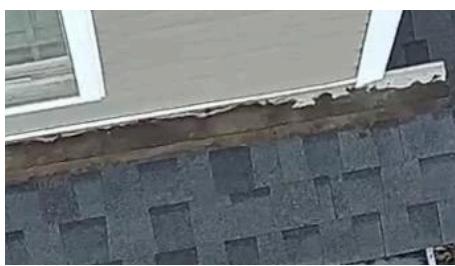
2.3. △ **Roofing: Flashing**

△ Deficiency Repair or Replace

Metal flashing was observed to be in place at the front of the home; however, the mastic or roof tar applied in these areas appeared to be deteriorating. Noticeable gaps were also observed at the left and right side. While no active leaks were noted at the time of inspection, deteriorated sealant and gaps may reduce weather resistance over time. Monitoring and maintenance or repair as needed is recommended to help prevent moisture intrusion.

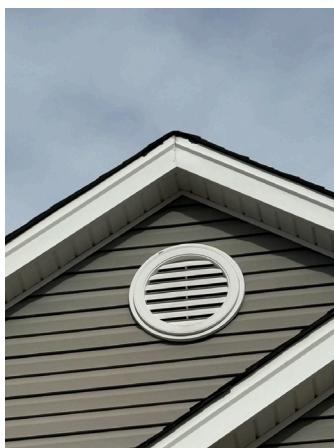
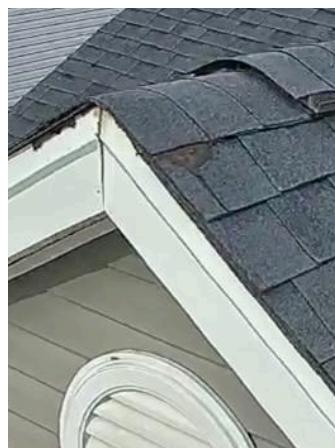
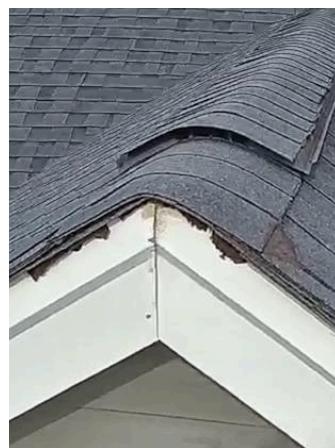
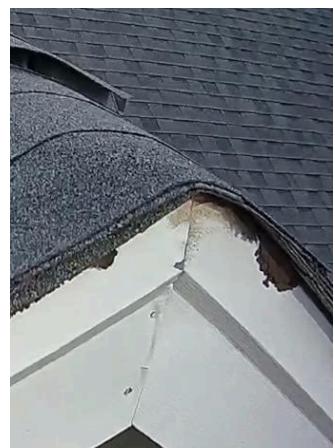
2.5. **Roofing: Soffit, Fascia, Eaves**

The soffit and fascia appeared to be in good condition, and the eaves showed no deficiencies at the time of inspection. At the front peak, near the highest point of the home, mastic was observed, suggesting a prior repair. No active issues were noted; however, monitoring this area over time for any changes or signs of moisture intrusion is recommended.

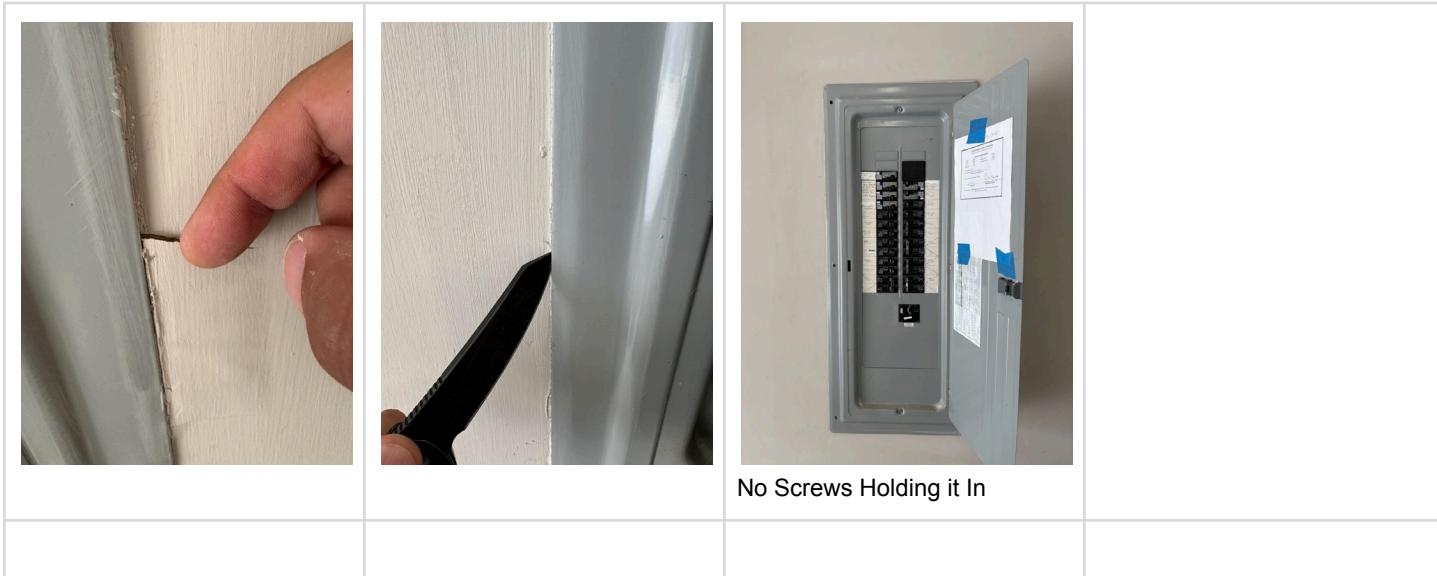
The electrical subpanel cover could not be removed at the time of inspection, even after all fasteners were removed, as it appeared to be adhered or sealed to the wall surface. Attempts to carefully score and gently pry the cover resulted in the surrounding paint and drywall beginning to detach, as shown in the referenced photo. The panel interior was therefore not accessible for inspection. The NCHILB Standards of Practice limit inspections to readily accessible components and do not require inspectors to cause damage to finishes or building materials to gain access. As a result, the internal components of the subpanel were not evaluated. If concerns exist, evaluation by a qualified electrician is recommended once safe, non-damaging access can be provided.

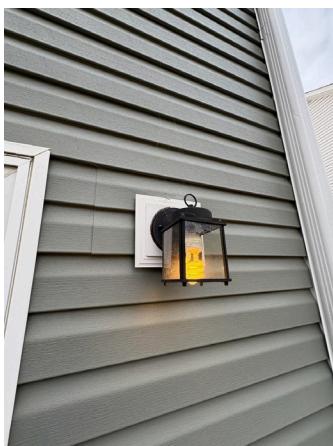
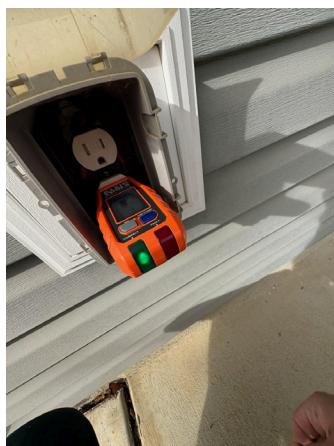
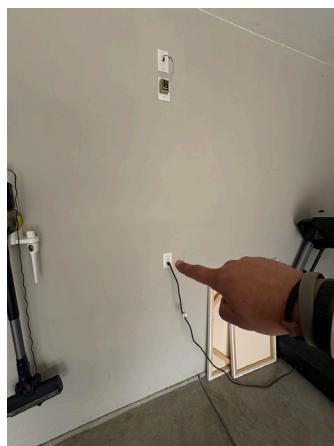
4.4. ▼ Electrical: Exterior Switches/Outlets/Lighting/Fans/Wiring

GFCI Reset in Back of Garage
for all Exterior Receptacles

Satisfactory

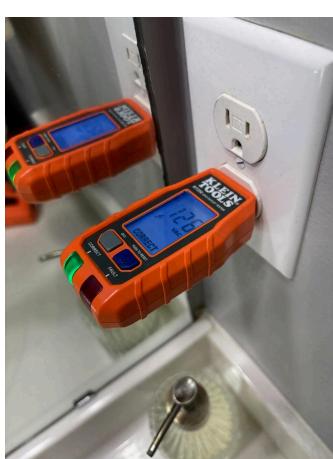
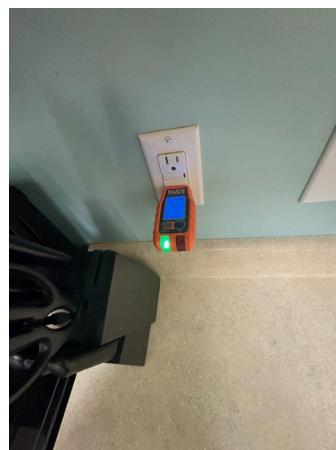
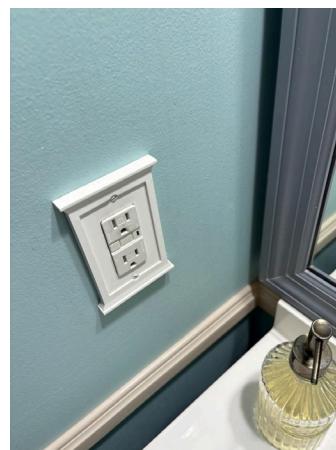
4.6. **Electrical: Interior GFCI Outlets (6ft. from plumbing fixtures)**

All Bathroom GFCI Reset
Found in First Floor ½
Bathroom

Satisfactory

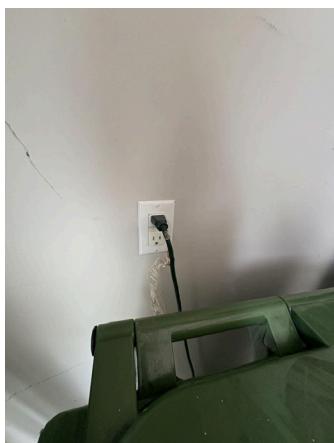
4.8. **Electrical: Garage Switches/Outlets/Lighting/Fans/Wiring**

Garage GFCI Reset

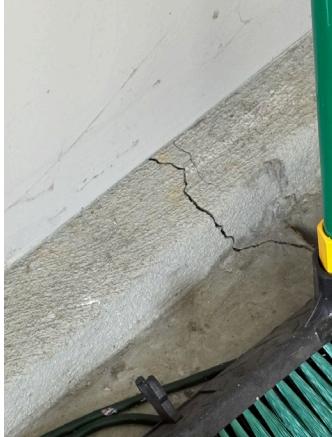
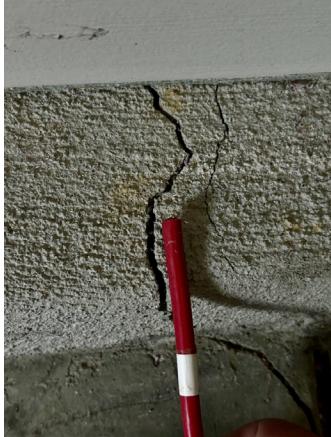
5.1. Garage: Overview (Ceilings, Walls, Floors/Slab, Foundation Walls and Sill Plates)

See Note in Structure: Foundation Material/Condition

The garage interior was only partially visible at the time of inspection, which limited the evaluation of the ceilings, walls, floor/slab, foundation walls, and sill plates. However, a crack was observed in the garage that appeared to correspond with cracking noted on the opposite side of the foundation. Due to limited access and visibility, the full extent and cause of this condition could not be determined. Cracks in foundation-related components may be associated with movement or stress and warrant further consideration. Further evaluation of the garage and foundation by a qualified professional is recommended – and reference should be made to the related note in the Structure: Foundation Material/Condition section of this report.

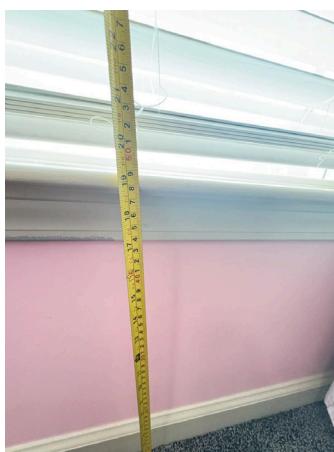
6.5. ⚠ **Interior: Windows**

⚠ Deficiency Repair or Replace

The upstairs interior windows were observed to be operational and in serviceable condition at the time of inspection. The window sills were observed to be relatively low to the finished floor, and window safety locks or fall-protection devices were not present. Low window sill heights may present a fall risk, particularly for children. Consideration should be given to installing window safety devices to help reduce the risk of injury.

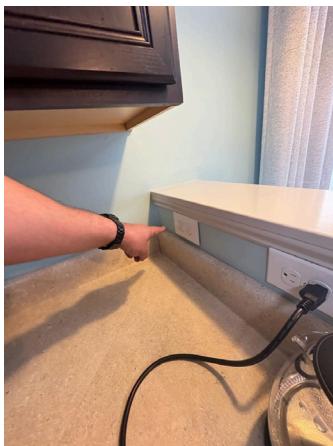
Disposal Switch

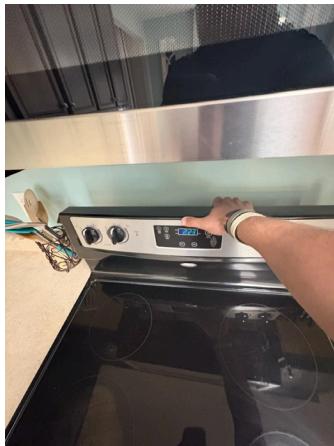
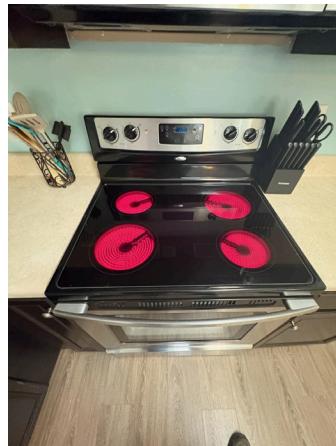
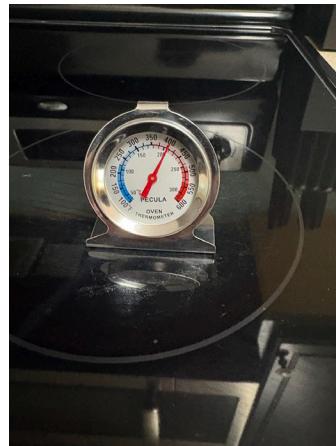
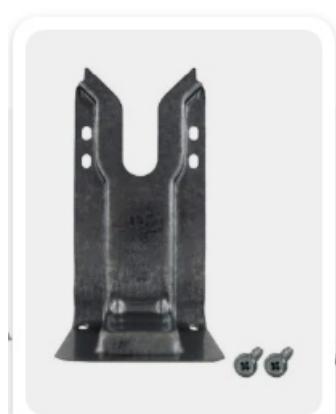
6.11. △ **Interior: Built-in Appliances – Oven/Cooktop**

An anti-tip device for the range was not observed at the time of inspection. Anti-tip protection is intended to help reduce the risk of the appliance tipping during use. Verification of proper anti-tip hardware and installation or repair as needed by a qualified contractor or appliance installer is recommended. In addition, the range was observed to be operating approximately 50°F hotter than the selected temperature setting, indicating the appliance may be out of calibration. Many ranges can be programmed or calibrated to correct temperature variance. These items are often addressed by homeowners who research and follow manufacturer guidance; however, evaluation and adjustment by a qualified individual or appliance service technician may be considered to help ensure proper operation and safety.

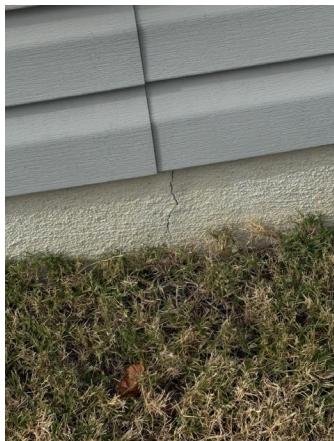
Hairline Crack – Right, Front

Several foundation cracks were observed, including hairline cracks at multiple locations and a wider crack at the left middle area measuring approximately 1/4 inch. Cracking at this location was also observed to correspond with cracking at the garage foundation wall. Hairline cracking can be associated with normal curing and typical settlement; however, the presence, width, and alignment of the larger crack warrant further consideration. While no signs of structural failure were observed at the time of inspection, further evaluation by a qualified structural engineer or foundation professional is recommended to assess conditions and provide written documentation regarding the foundation at the time of inspection, which may help provide clarity and reassurance regarding the foundation's condition.

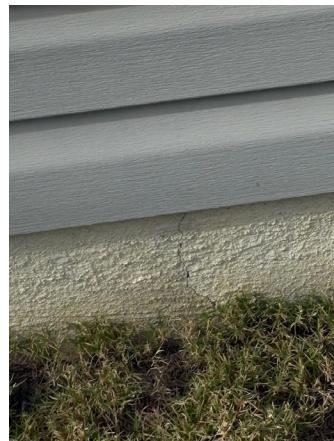
Hairline Crack – Right, Middle

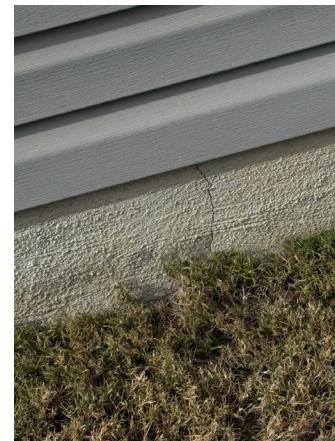
Hairline Crack – Right, Back

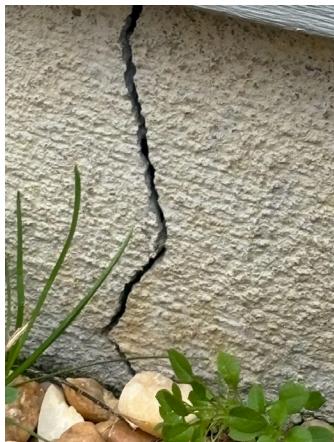
Crack – Left, Middle (Close to 1/4 inch)

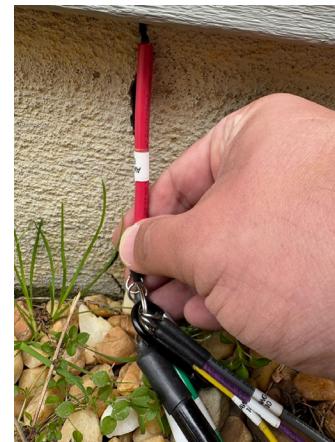
Crack – Left, Middle
(Corresponds to Garage Foundation Crack)
