**Site Address:**  
123 Street Name  
Raleigh, NC 27613

**Kevin Polonofsky - #6078**  
[kevinp@relihi.com](mailto:kevinp@relihi.com)  
919.805.3955

**Inspection Date:** 00.00.26 – 12p

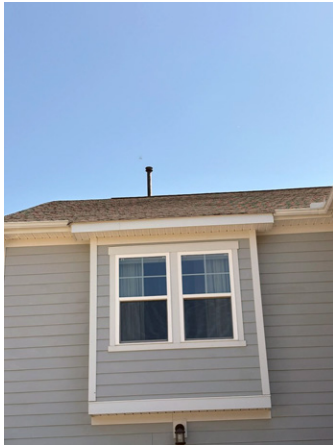
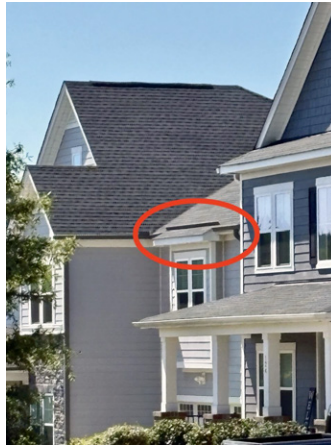
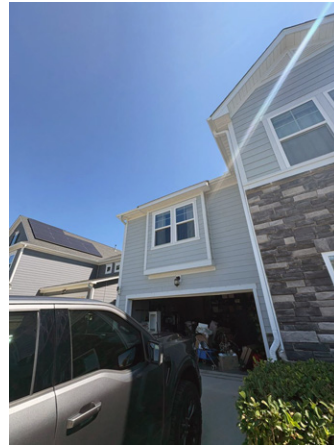
At the front roofline above the garage, a projecting bay-window area was observed without a gutter or other visible roof-runoff diverter to help direct water away from the projection below. Concentrated roof runoff at this location may increase moisture exposure to the bay-window roof, trim, siding, adjoining wall materials and driveway. A neighboring home was observed to have a runoff-diversion feature in a similar location; however, neighboring construction was used only as a visual reference and not as a determination of required installation. Recommend evaluation by a qualified roofing or gutter contractor and installation of appropriate drainage or water-diversion measures if needed to better manage roof runoff.

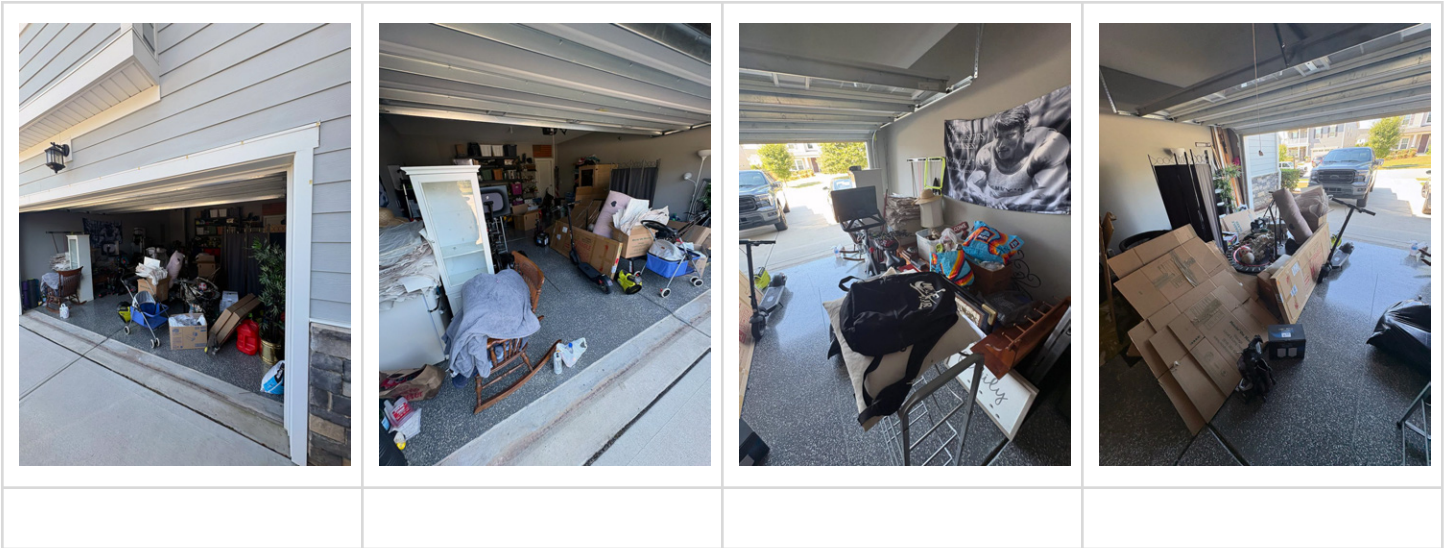
Stored belongings, packing materials, and homeowner debris limited visibility of portions of the garage walls, slab edges, foundation walls, and sill plate areas at the time of the inspection. The exposed floor surface also appeared to have an epoxy flake coating installed, which limited direct observation of the underlying concrete in covered areas. Readily visible and accessible portions were inspected; however, concealed areas behind stored items and beneath finished floor coatings could not be fully evaluated as part of this visual, non-invasive inspection.

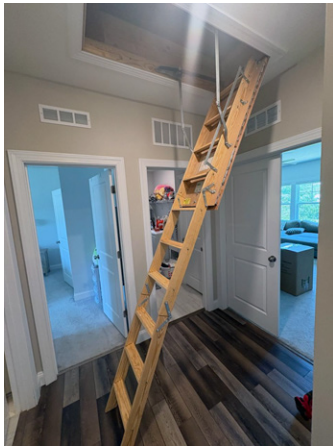
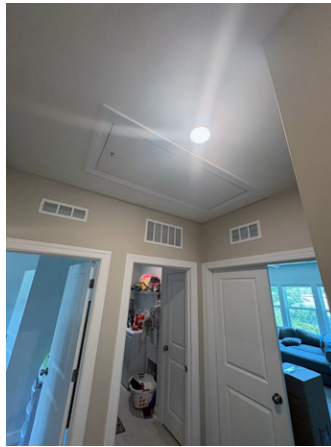
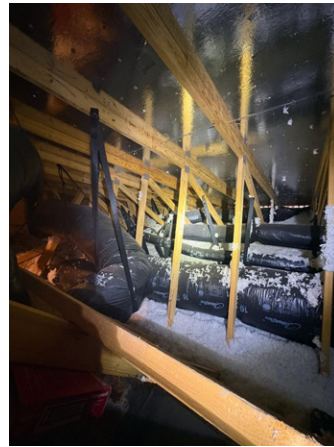
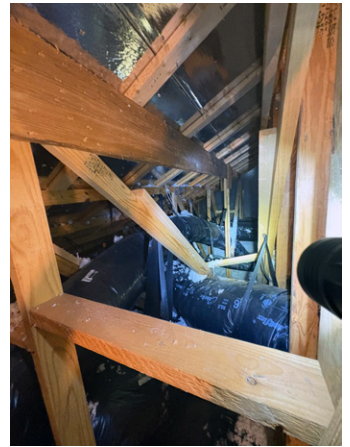
*The front and right portions of the attic were not traversed because blown-in insulation concealed the truss bearing/footing areas and numerous HVAC ducts limited safe access. Traversing these areas could have disturbed or compressed the insulation and damaged or displaced ductwork. The inspector evaluated the readily visible and safely accessible portions of the attic from available access points, and no readily visible deficiencies were observed that warranted disturbing these systems. Areas that could not be safely accessed or viewed remained limited from inspection.*

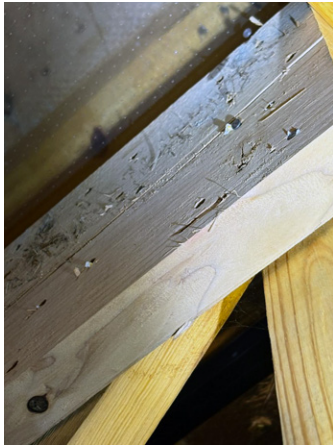
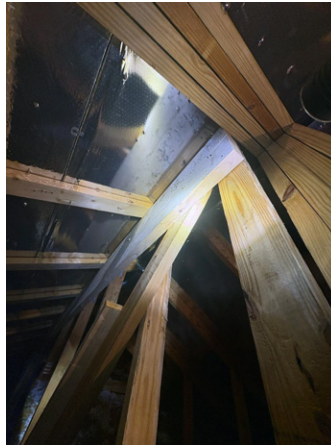
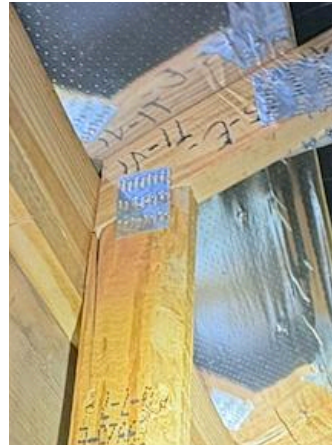
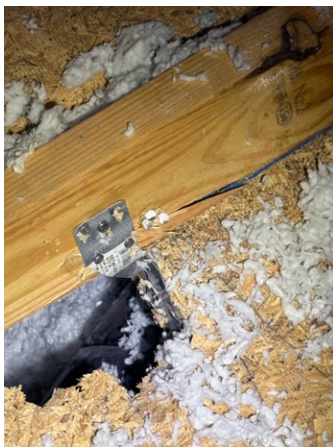
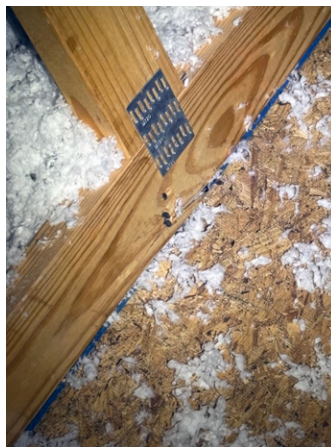
#### 4.3. Attic: Ceiling/Sheathing and Structure/Support Systems

Deficiency ▾ Further Evaluation Required ▾

In the attic, to the right of the stairs just beyond the landing area, a purlin spanning across the upper roof-framing system was observed to be cracked near the front portion of the member. The first truss chord connected at this location was also visibly split near the top and exhibited additional cracking near the lower portion where supporting members had been fastened. These conditions affect multiple connected roof-framing components, and the extent and structural significance of the damage could not be determined during this visual inspection. Recommend evaluation by a licensed structural engineer to determine whether repair or reinforcement is needed and to provide repair recommendations as appropriate.

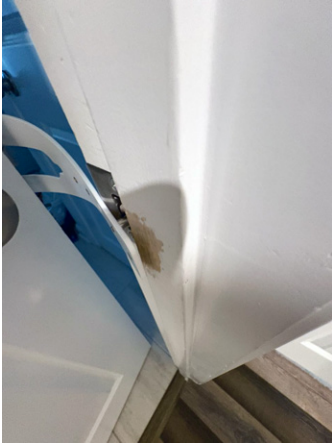
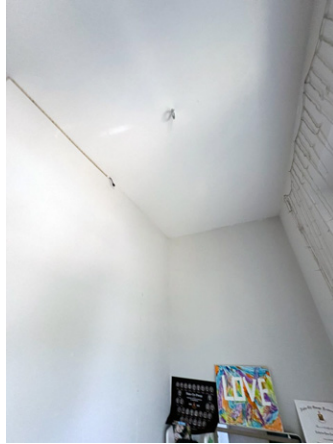
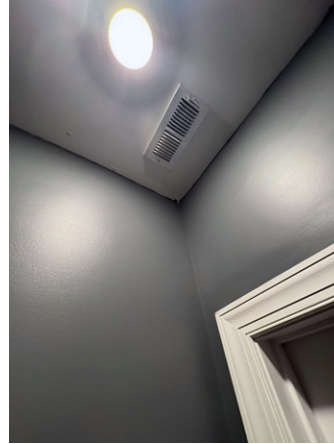
## 5.2. Interior: General Observations

Minor cosmetic conditions were observed throughout the home, including scuff marks on walls and ceilings, rub marks near door hinges, hooks and light fixtures attached to finished surfaces, minor drywall imperfections, and isolated nail pops. These conditions appeared cosmetic in nature and were not observed to affect the intended function of the associated components at the time of the inspection. No corrective action is required as part of the home inspection; repair or touch-up may be performed as desired.

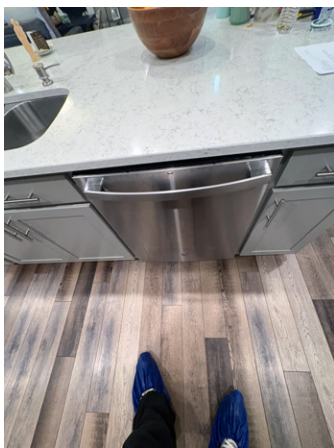
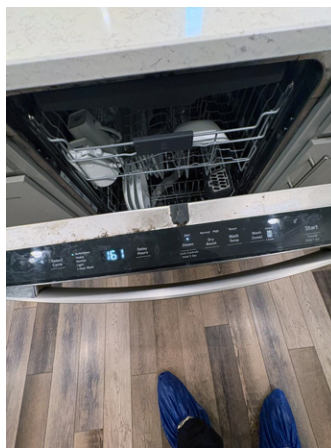
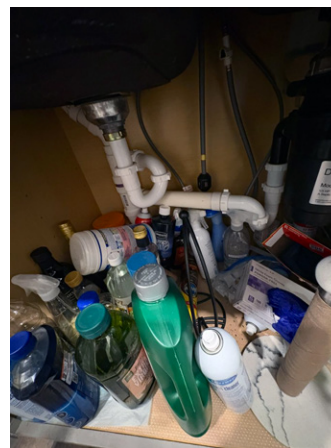
## 5.9. Interior: Built-in Appliances – Dishwasher

*The dishwasher was not operated at the time of the inspection because homeowner belongings were stored inside the unit. To avoid disturbing or damaging personal property, the dishwasher was not functionally tested. The readily visible exterior portions of the appliance were observed where accessible; however, its operating condition could not be determined during this inspection.*

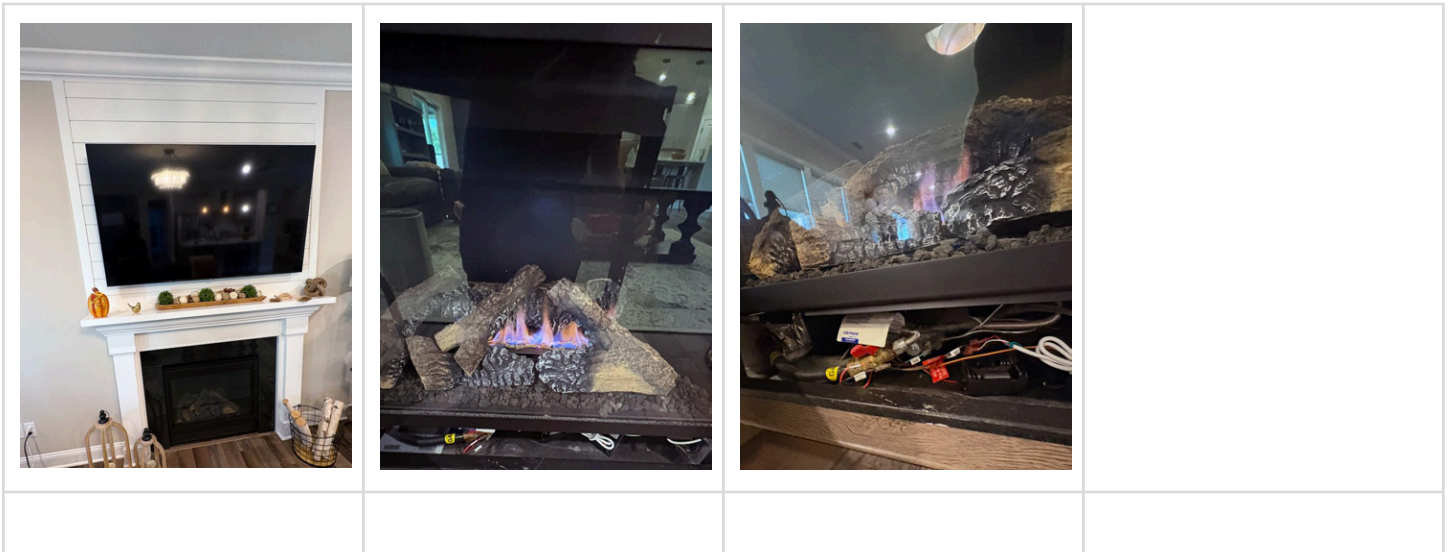
Location(s): Living Room

Gas fireplace inserts are fuel-burning appliances and should be periodically inspected and maintained by a qualified fireplace or gas-appliance professional. Routine service can help verify proper operation of the burner, ignition system, venting, seals, controls, and other accessible components. Recommend following the manufacturer's maintenance guidance and having the unit professionally serviced at appropriate intervals.

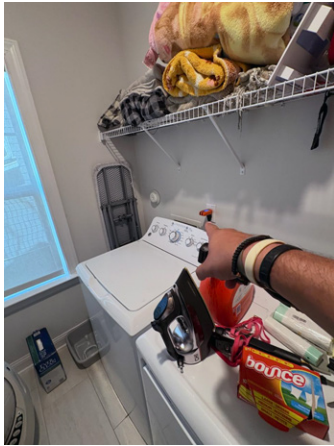
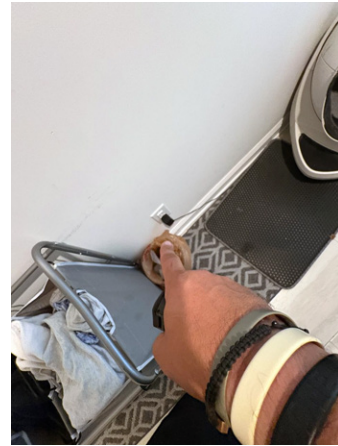
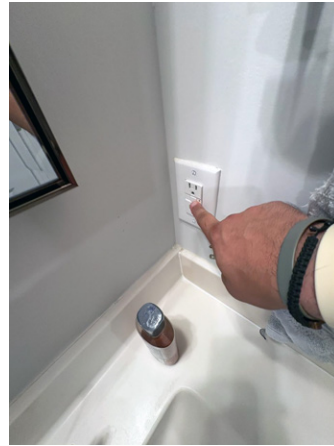
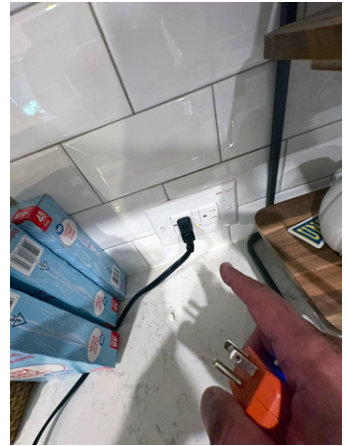
Laundry GFCI Reset

All Bathroom GFCI Reset in  
Upstairs, Front Left Bathroom

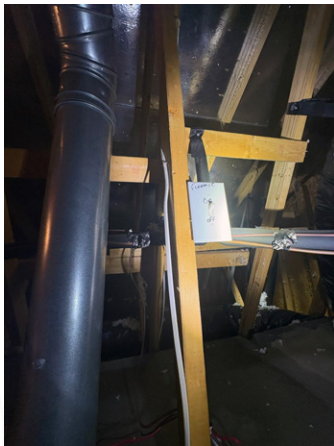
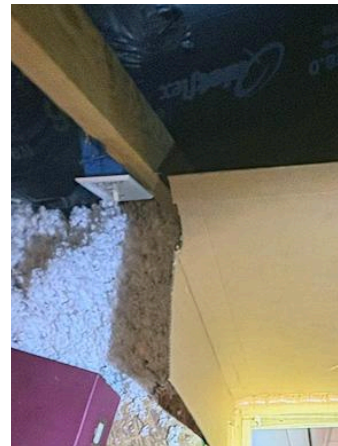
Light at back of Entryway

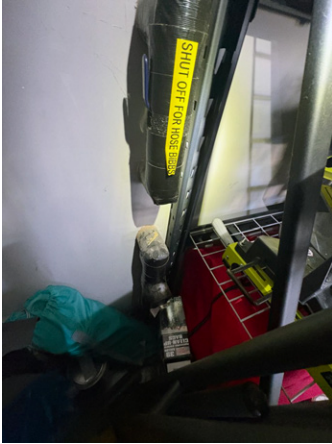
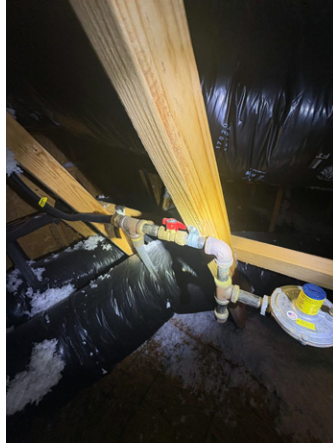
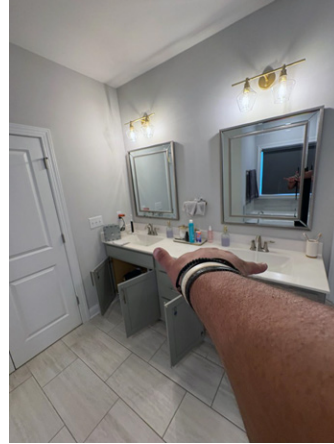
A noticeable reduction in water flow was observed when three or more plumbing fixtures were operated simultaneously. The plumbing system remained functional during testing; however, if stronger simultaneous flow is desired, the client may wish to have a qualified licensed plumbing contractor evaluate the system for possible improvements to water pressure or distribution performance.

The main water shutoff and exterior hose bib shutoff valves were located at the back-left area of the garage. The main gas shutoff was located in the attic, to the left of the attic stairs and across from the HVAC equipment. These locations are documented for homeowner reference.

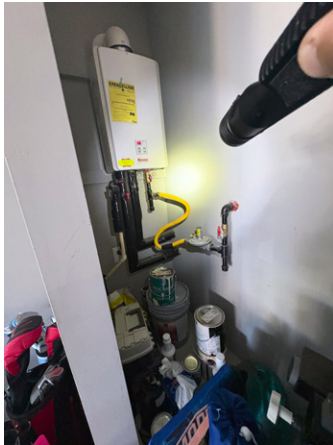
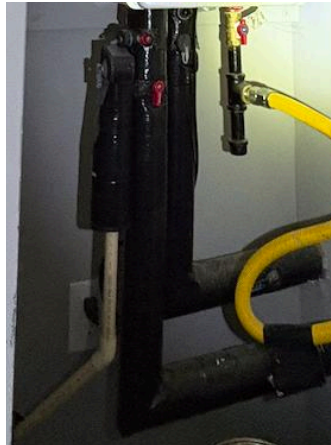
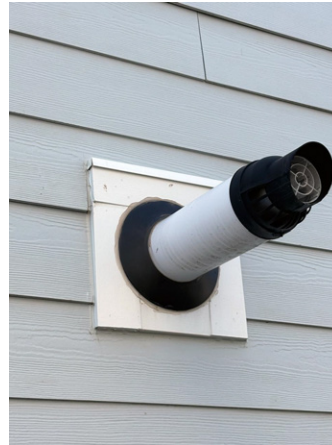
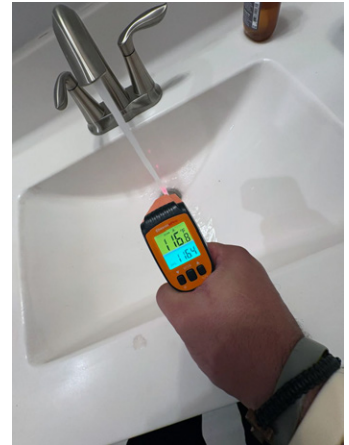
Homeowner belongings stored in the garage limited access to the water heater and prevented a clear view of the manufacturer data tag. The readily visible portions of the unit were observed where accessible. The water heater appeared to be vented to the exterior, a gas shutoff valve was visible nearby, a sediment trap/drip leg was present, and visible piping was insulated. The model, serial number, and age could not be confirmed due to the limited access. Hot water temperature measured at the fixtures was approximately 116°F at the time of the inspection. This temperature is documented for informational purposes and reflects conditions present at the time tested.

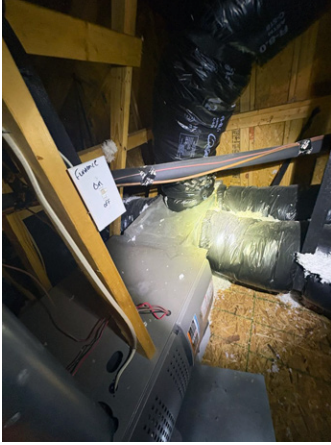
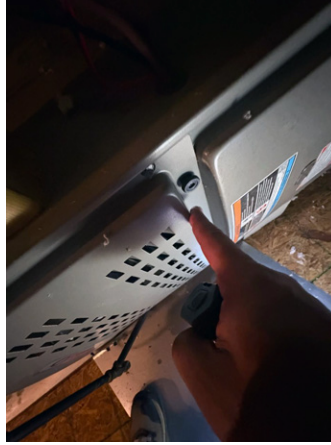
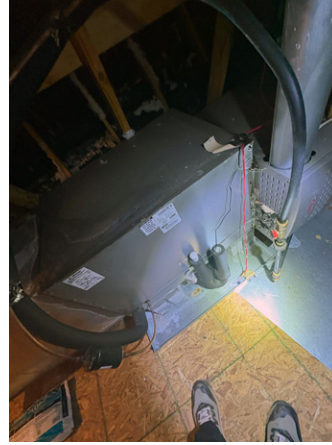
The furnace cabinet could not be fully opened at the time of the inspection because the lower securing screw was missing and the upper screw was overtightened and could not be safely removed without risking damage to the equipment. As a result, the readily accessible internal furnace components could not be visually evaluated. Because the furnace could not be adequately accessed for inspection, the heating system was not operated by the home inspector. Recommend evaluation and servicing by a qualified licensed HVAC contractor, including correction of the cabinet fasteners and confirmation of proper heating operation.
